Fire Risk Assessment

Fire Risk Assessment of:	Unit 5, Castleham Road, St Leonards on Sea
Report Completed By:	Ian Warne
Date:	1 st February 2021

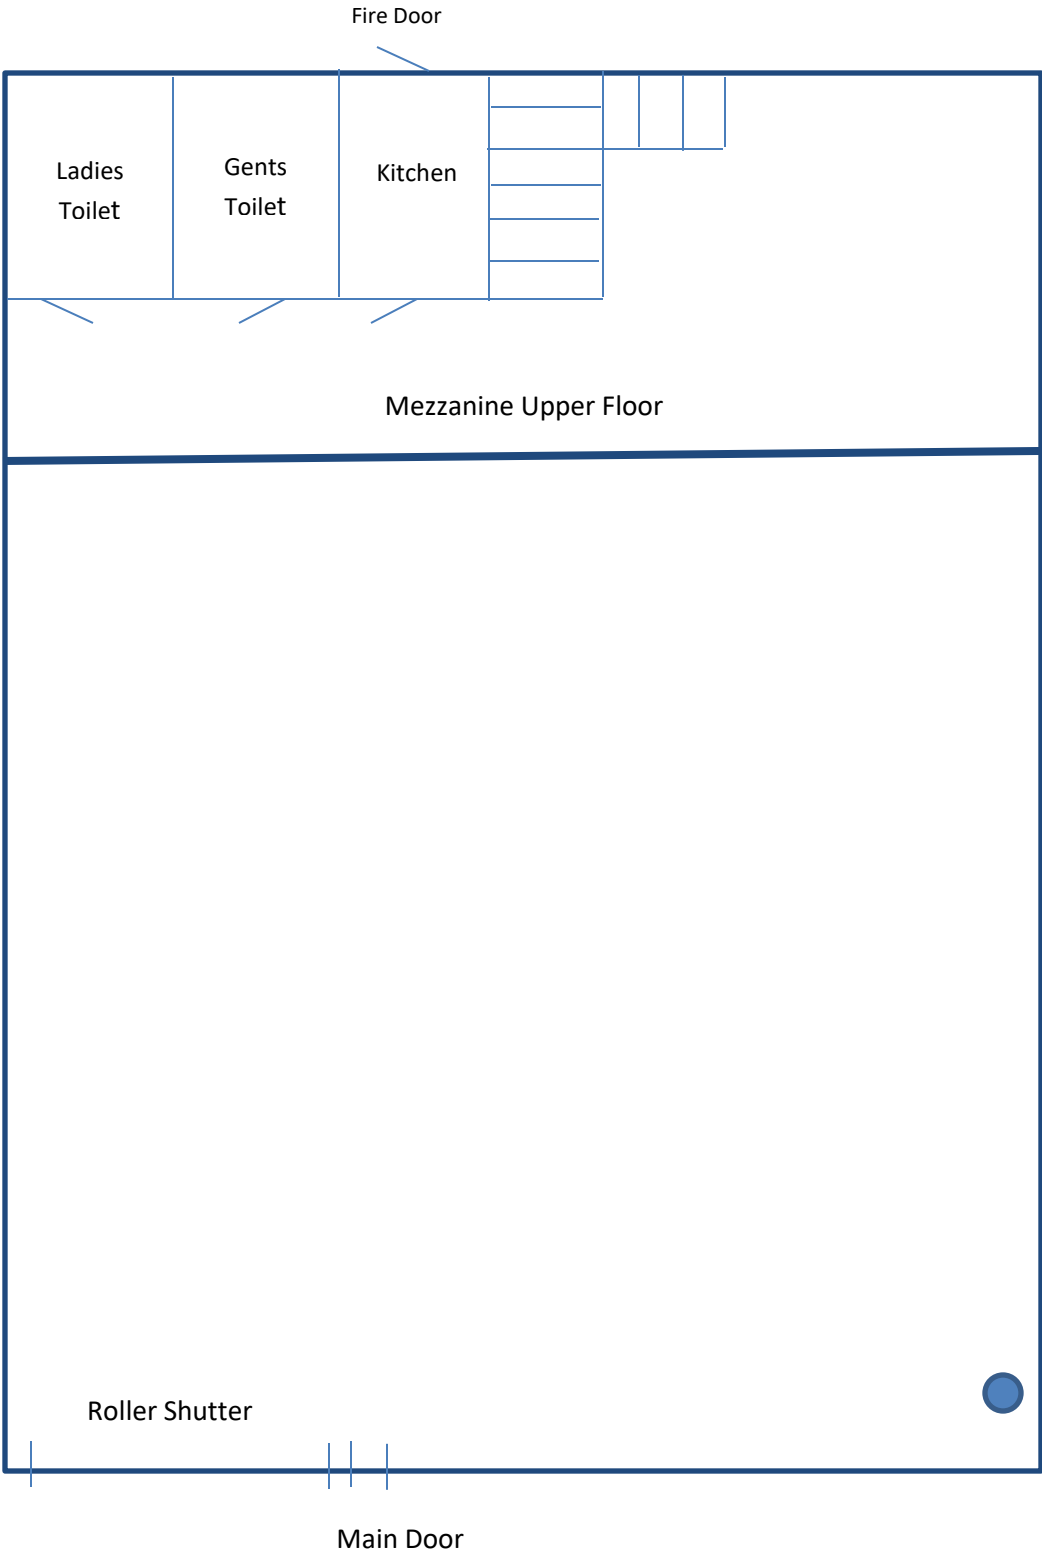
Compressor
Shed

At the front of the building is a personnel and roller shutter door into gated compound. Within the gated compound is a compressor in a metal shed and a wheely bin.
